SUBJECT John Anglin, Clarence Anglin and
Frank Lee Morris Escape from Alcatraz

FILE NUMBER 76-26295

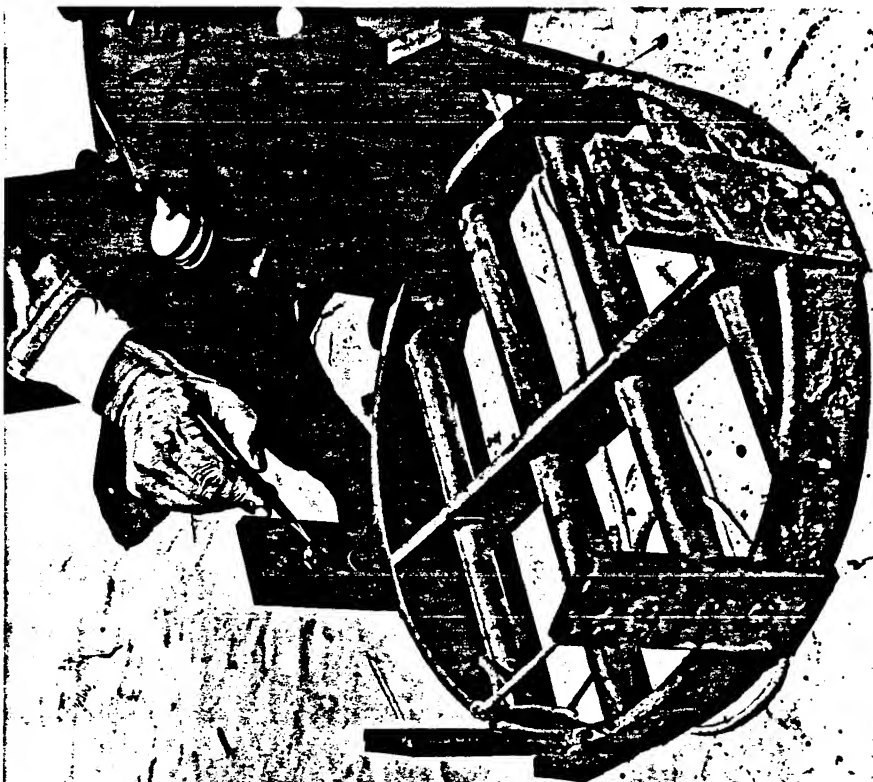
1-3 Same as 1-2 with the exception that pencil is used to point out the bolt head made of soap which is one of two found on the roof.

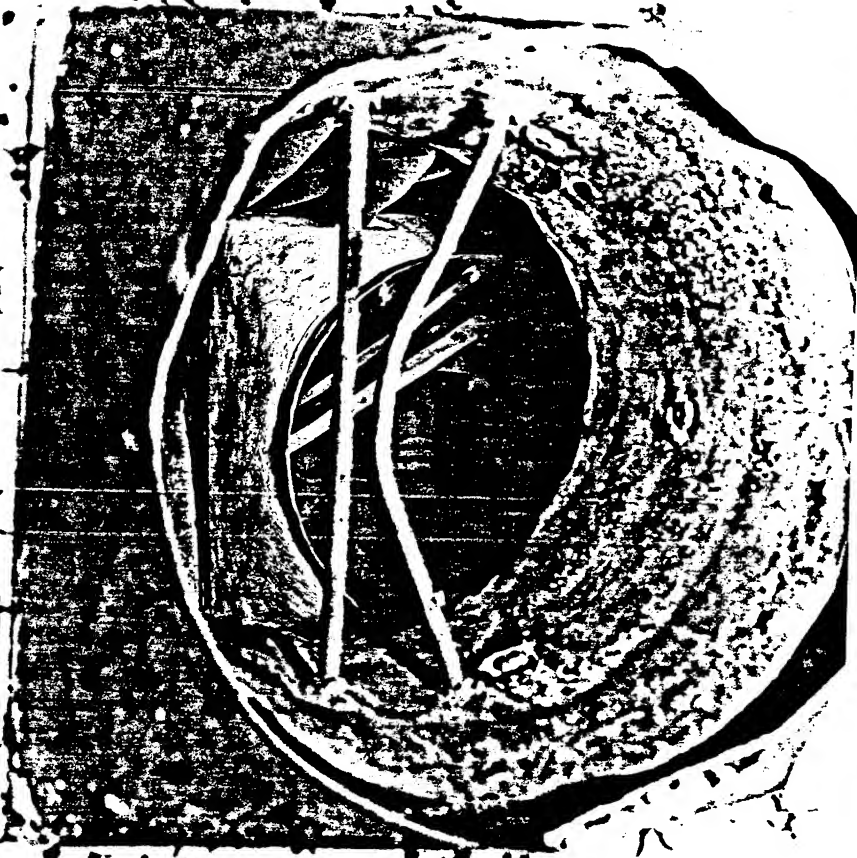
1-8 This photograph was taken directly over the ventilator opening on the roof and shows the vent re-enforcing rod and the stud holes normally used to fasten down the heavy galvanized grate shown in photographs 1-1, 2, and 3. Immediately below the opening may be seen the top of the motor housing which is normally offset from the roof opening and when in operation is joined by a galvanized gooseneck connection. The blades of the "squirrel cage" type air impeller may be seen just above the bent portion of the re-enforcing rod. The bent rod is on the eastern side of the hole.

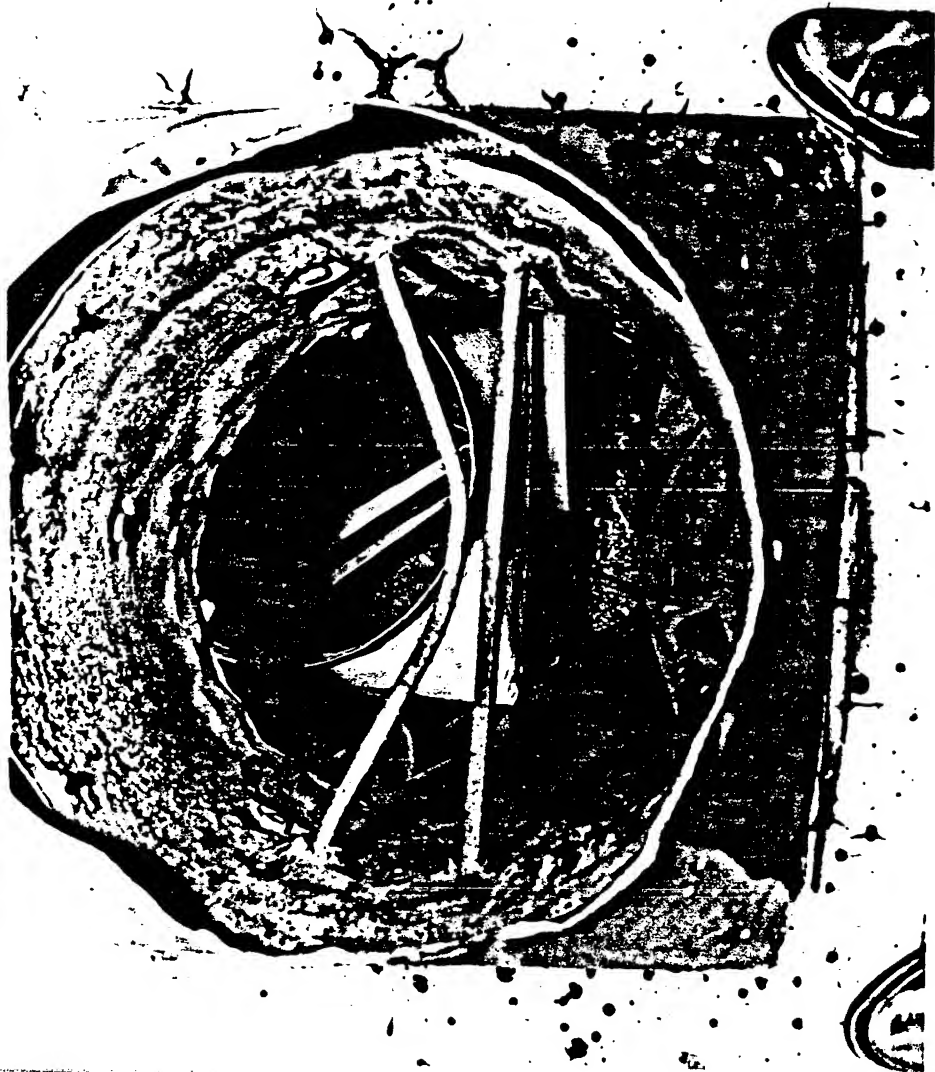
1-9 Same as 1-8 with the exception that more detail is shown concerning the blankets which were used to shield light from entering this opening.

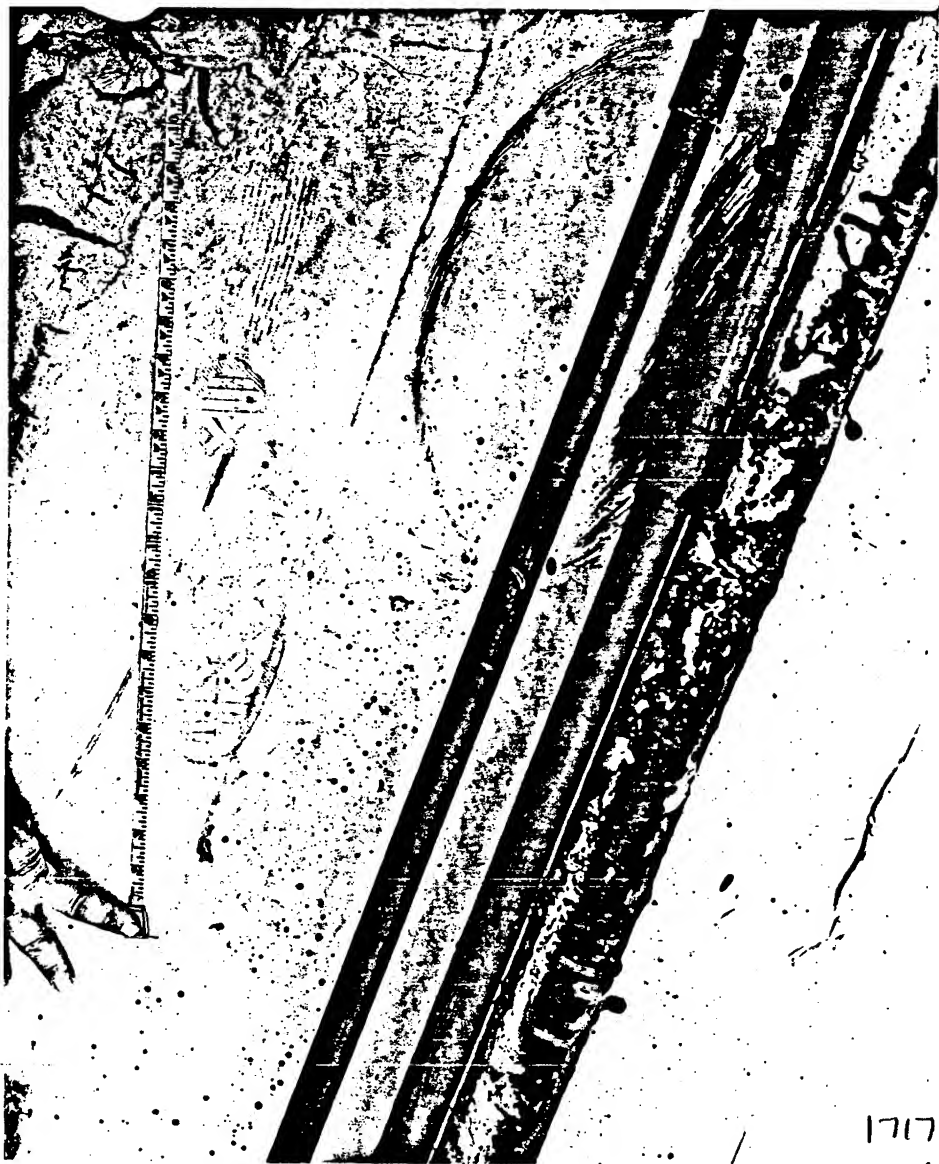
1-10 This is a photograph of an imprint of what appears to be the left foot. This print is headed in a northwesterly direction. The imprint appears to be that of the sole of a tennis shoe and is one of a number of fragmentary such prints visible on the roof indicating the direction of travel.

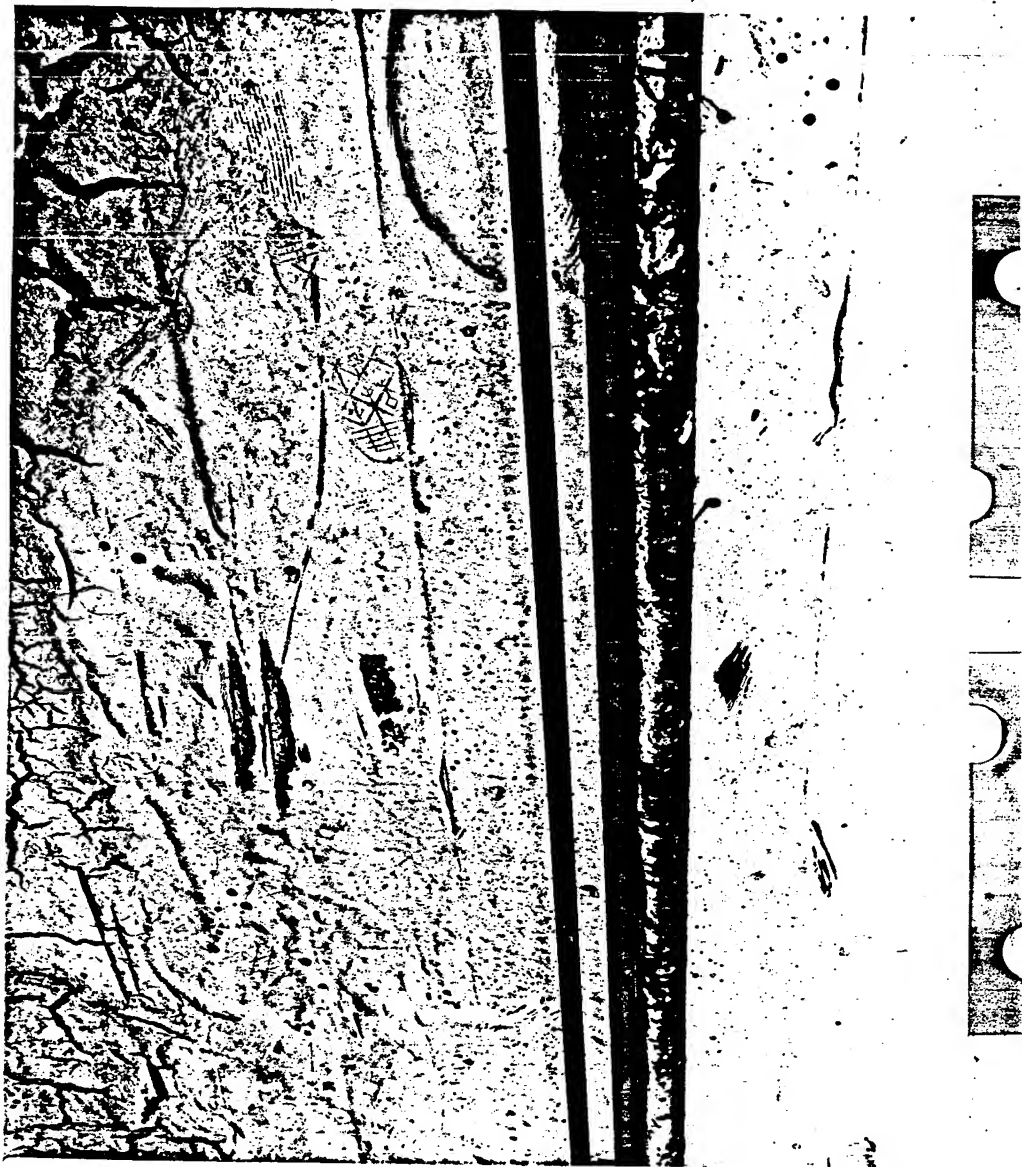
1-11 Photograph of two foot-print impressions, left one being the same as appearing in 1-10. Both prints headed in a northwesterly direction toward the water tower. While the impression of the foot print at the right appears to be distorted, it is a clear print and the angle of the photograph makes it appear in a distorted manner. The distance between the two prints was four feet one and one-eighth inches, indicating that someone apparently was running. These photographs were taken between the utility pipe and the skylight, which may be seen in photograph 1-7.

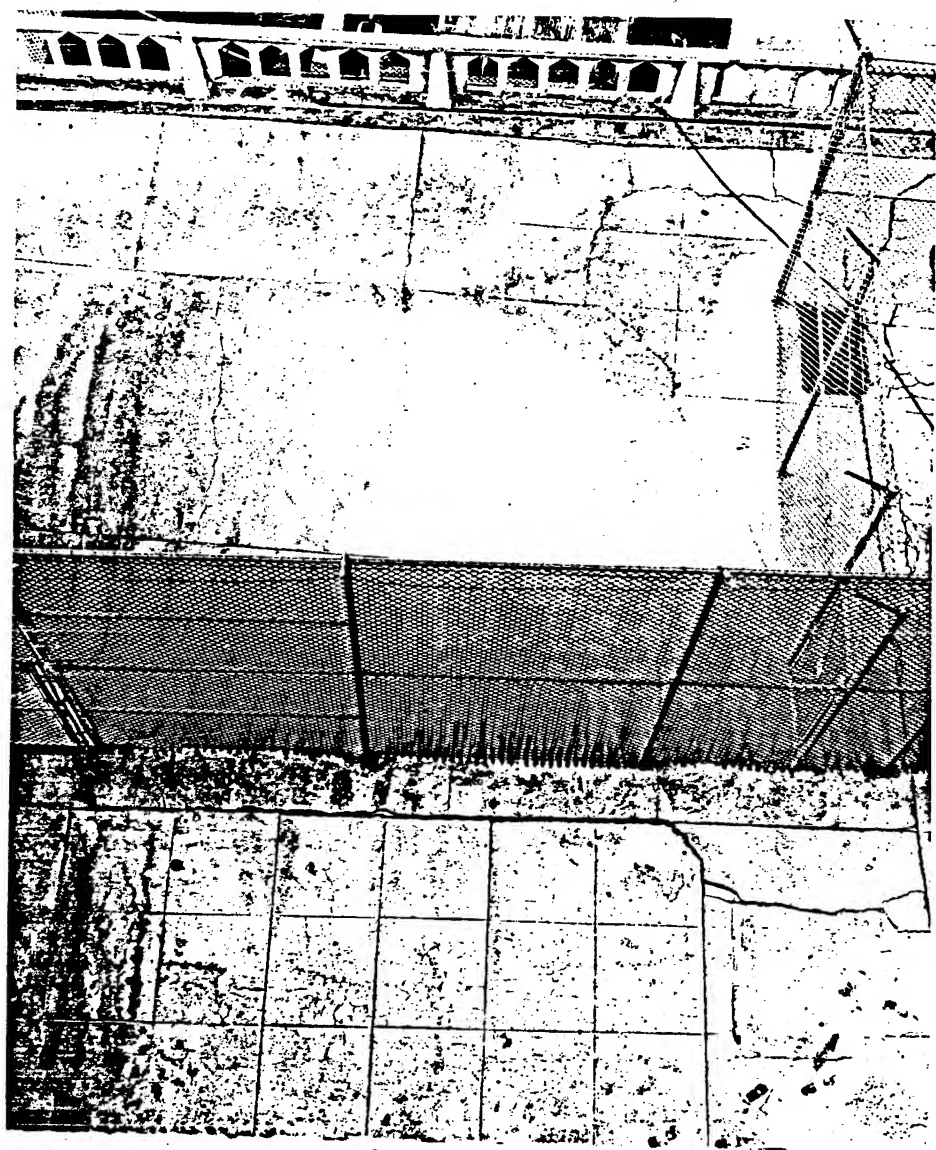
1-12 This photograph was taken from the north end of the building looking down to the enclosed ground area which is believed to be the area the Subjects descended to. The distance from the top ledge of the building to the concrete shown in the lower foreground is approximately forty-five feet.

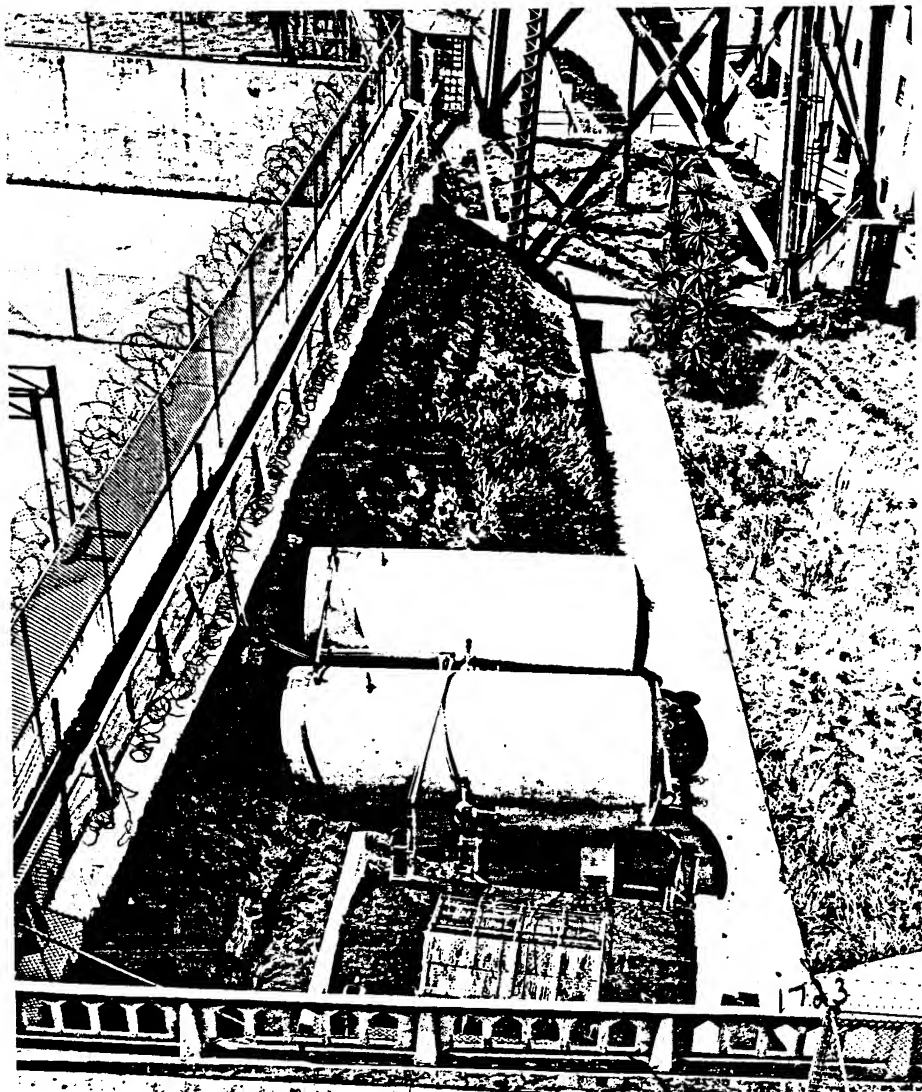
- 2-1 Photograph taken from top of prison building looking in a northern direction. The concrete decorative wall shown at bottom of photograph is the same as appearing at the top of 1-12. The two tanks shown in the foreground are salt water tanks with the base of the water tower shown at upper right. Top center is guardhouse number 3 and is not manned during the night hours. It is noted that lower left center along the fence, which encloses the walk to guard tower number 2, the barbed wire appears to have been cut and may have been the area over which the Subjects were able to make their escape.

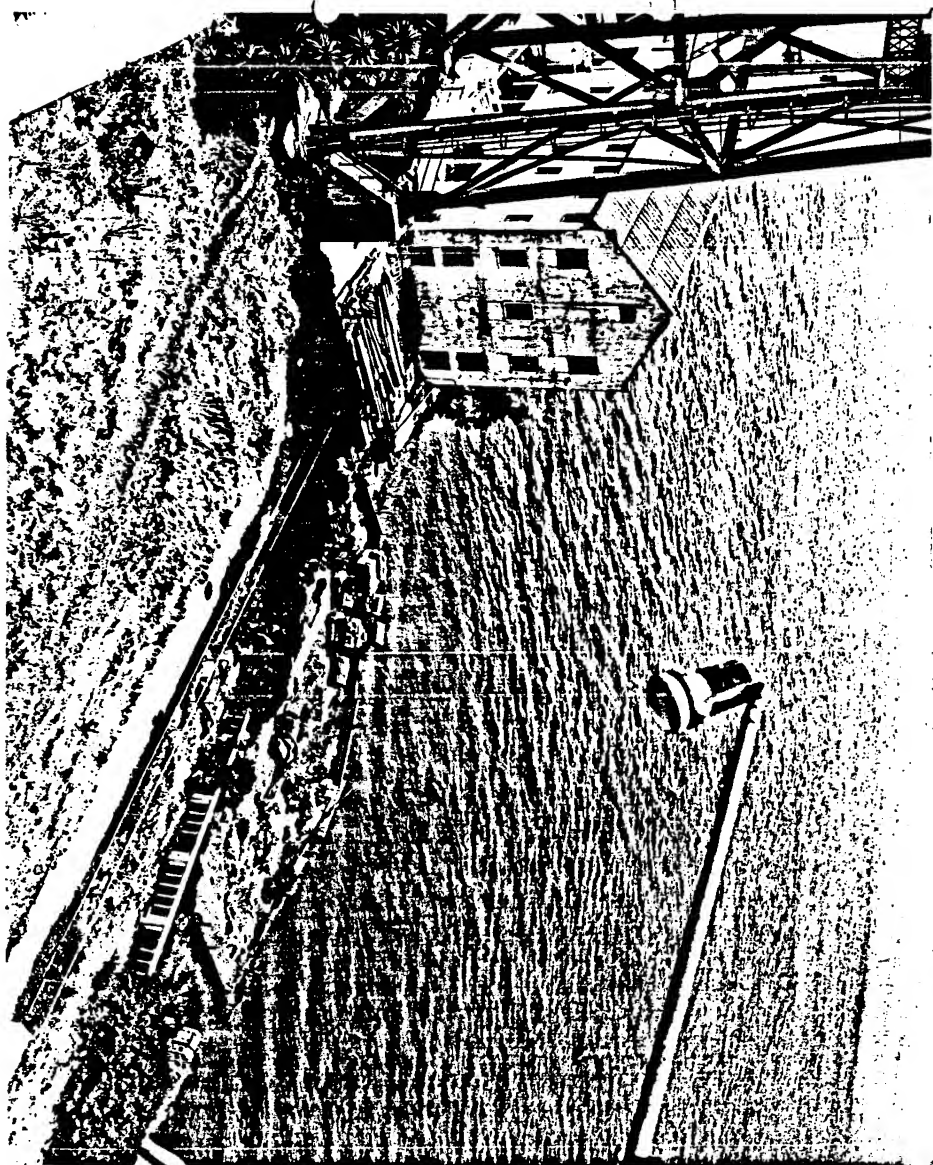
Photograph taken from roof as in preceding photograph, however this photograph shows the type of electrical fixture used to flood the sides of the building with light during the evening hours. Two such lights are spaced across the narrow or protruding end of the prison building and are spaced approximately ten to twelve feet apart. These lights receive their power from an externally mounted outlet on the inside of the edge of the roof and all connections were found to be tight and show no indications of having been tampered with. All lights were found to be in working order and were illuminated at the request of the water photographer. The area at lower right is leading to the water line. It is the area believed to have been used by the Subjects in reaching the water.

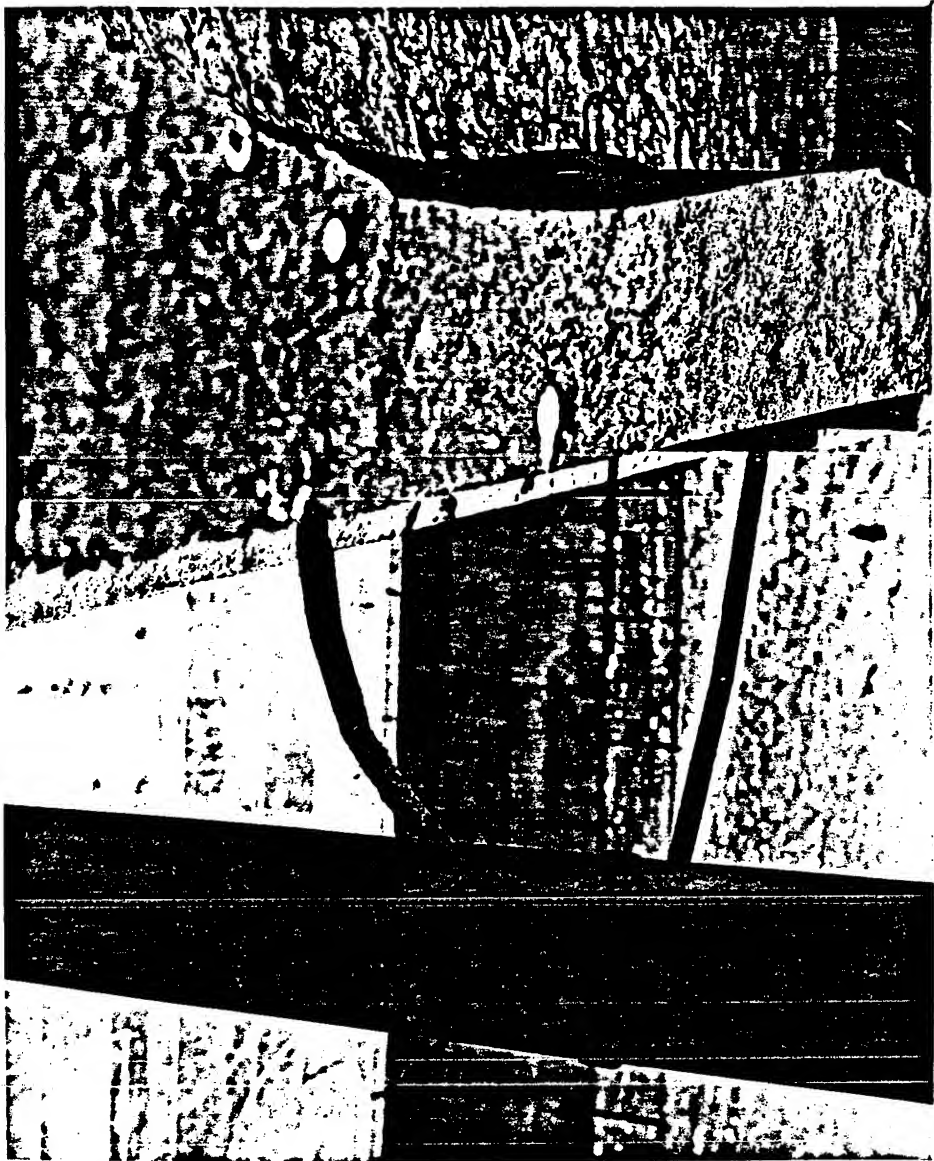
2-6

Photograph taken from top of prison building showing the edge of the building which extended approximately twenty-eight to thirty inches above the roof line. Immediately to the right will be observe angle iron brackets used to support the stack from the bake oven. This stack extends several feet above the edge of the roof and is approximately ten to twelve inches in diameter and appears to be made of cast iron.

The portion of the bracket which is visible in center foreground is noted to be bent. Prison guard [REDACTED] observed that this is a recent bend as he is quite certain this was not there the last time he observed it approximately a month ago. The stack extends to practically ground level on the exterior of the building.

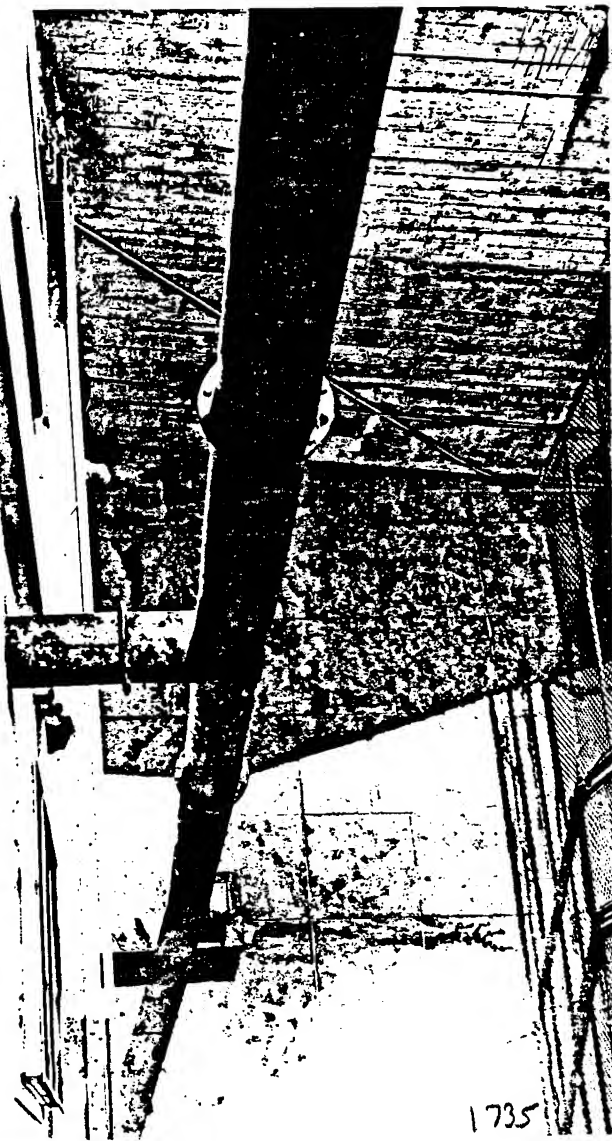
2-7 Photograph taken by leaning over the edge of the building showing the bake oven stack extending from above the roof line to the clean out on the concrete slab at ground level. The edge of the building is at left center and the distance from this to ground level is approximately forty-five feet. The wire screen topped with barbed wire seen at lower right is approximately twelve feet high.

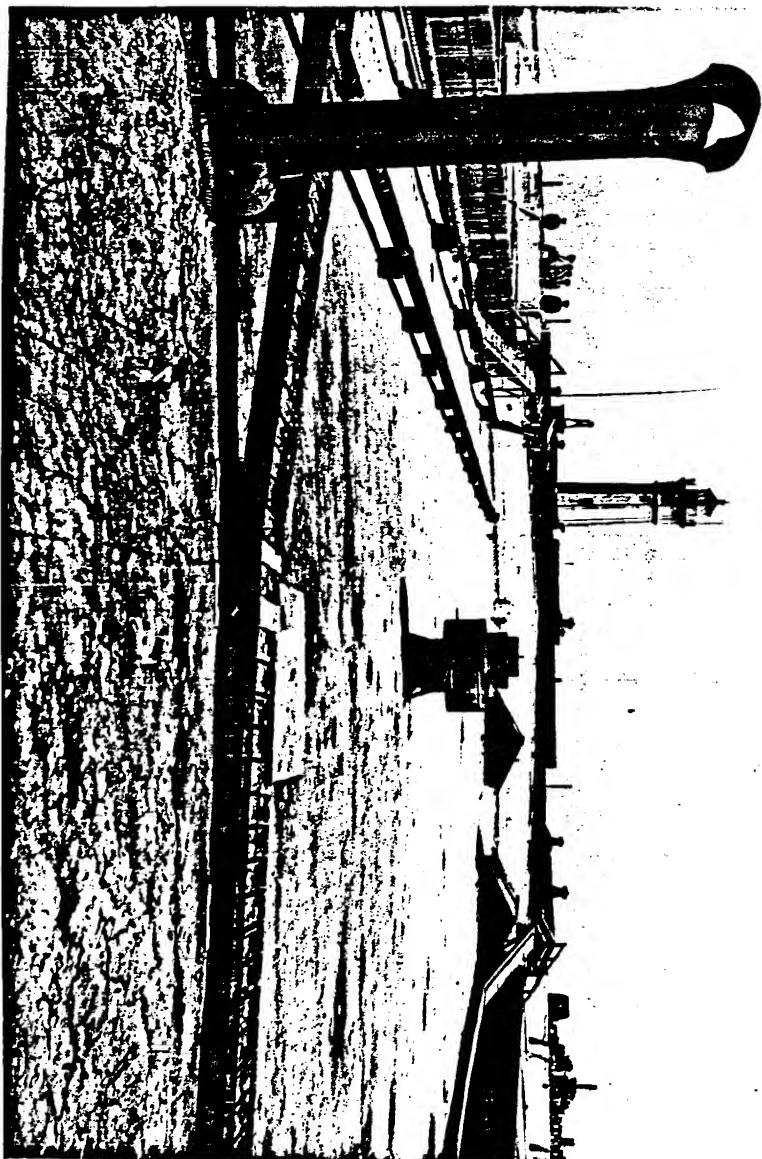
2-10 Photograph taken showing general roof area looking in a southerly direction from the bake oven stack toward the Coast Guard lighthouse. The change in the roof elevation from Cell Block A, B, and C, etc., may be observed with catwalks running on both sides of the picture. A paddle was found under the catwalk in approximate location indicated by the individuals seen in the photograph left center.

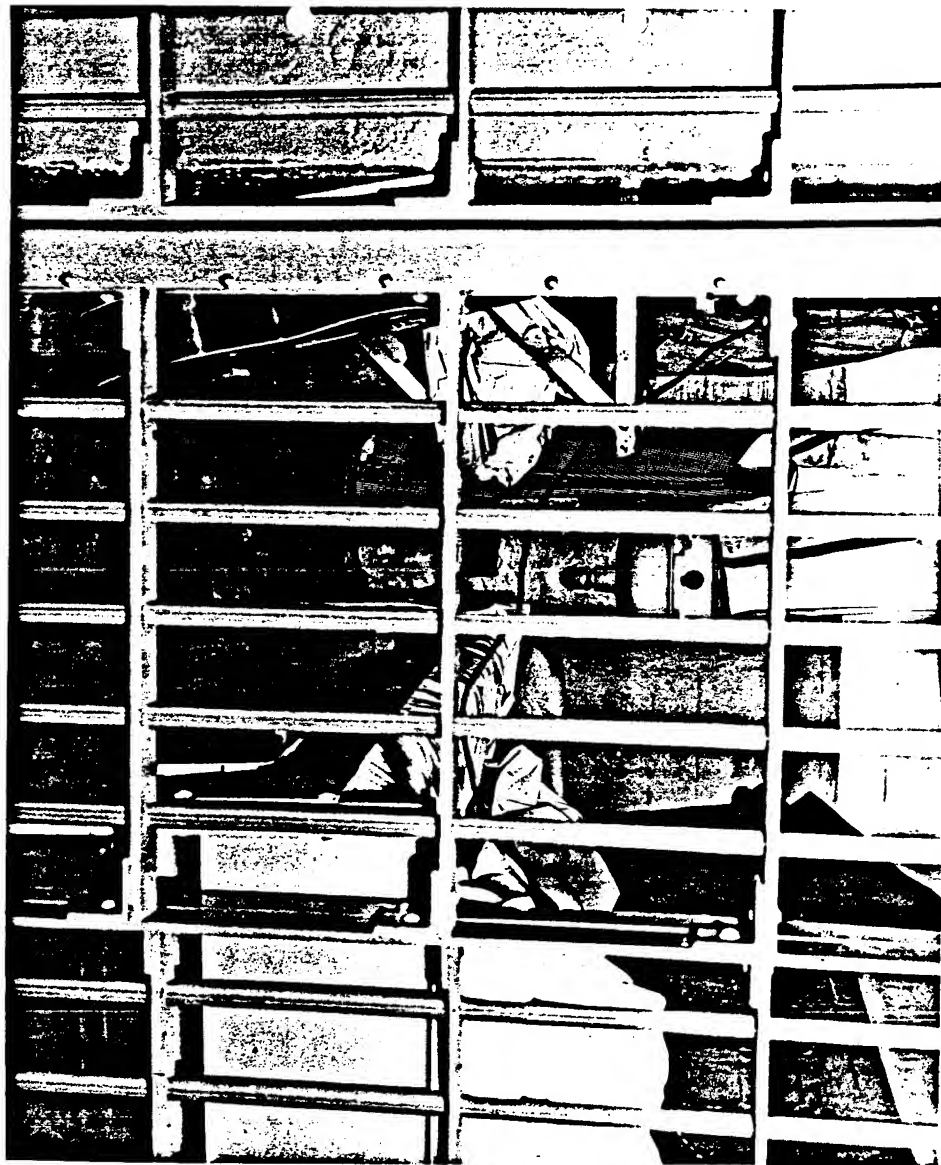
3-2 Photograph of the same cell taken head-on showing the opening at the rear of the cell under the wash basin which permitted Subject CLARENCE ANGLIN to escape. In this photograph the hole is partially covered by a piece of cardboard, the source of which and use of which is unknown.

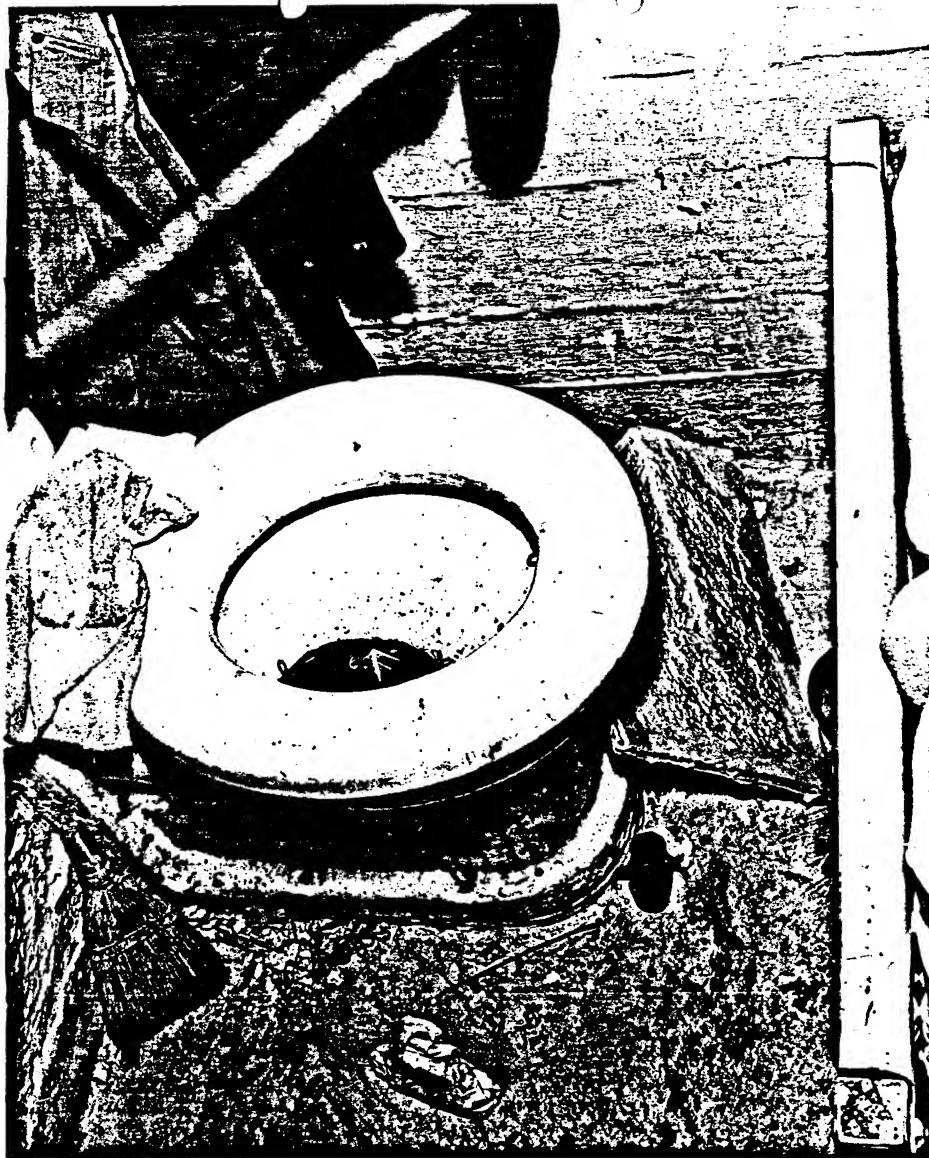
3-4 Photograph taken in the cell of CLARENCE ANGLIN showing detail of toilet facility at foot of bed. Portions of soap scraps and plaster are visible as are fragments of hair. Immediately forward of the toilet seat is a portion of the grill made by Subjects to replace that removed from the cell. The portion of the small circular object seen is the cup which is supplied to prisoners for shaving purposes. This cup contained water and a brush.

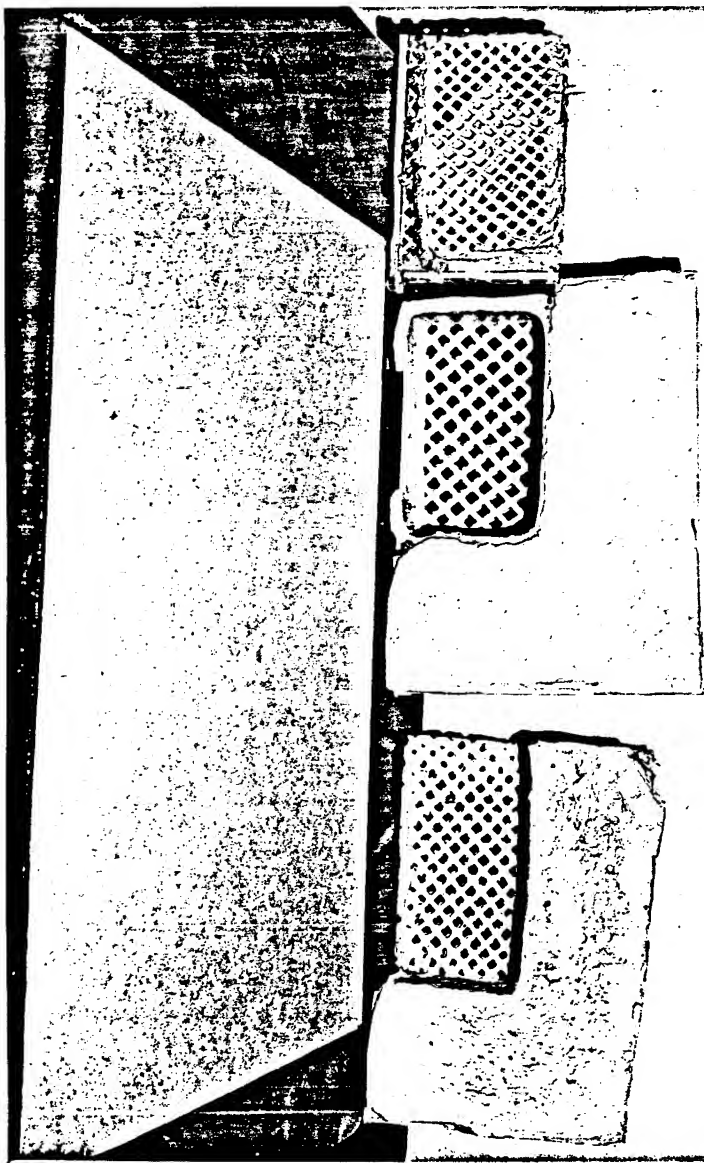
Replicas of ventilator grills placed in openings in cells through which Subjects exited to utility area between cell blocks B and A. Replica on the left is the actual size of the metal grill originally in the wall; it was reproduced, as were all the rest, from artist's drawing board which was faced with a linen-type substance. This material is available to all inmates for art painting purposes.

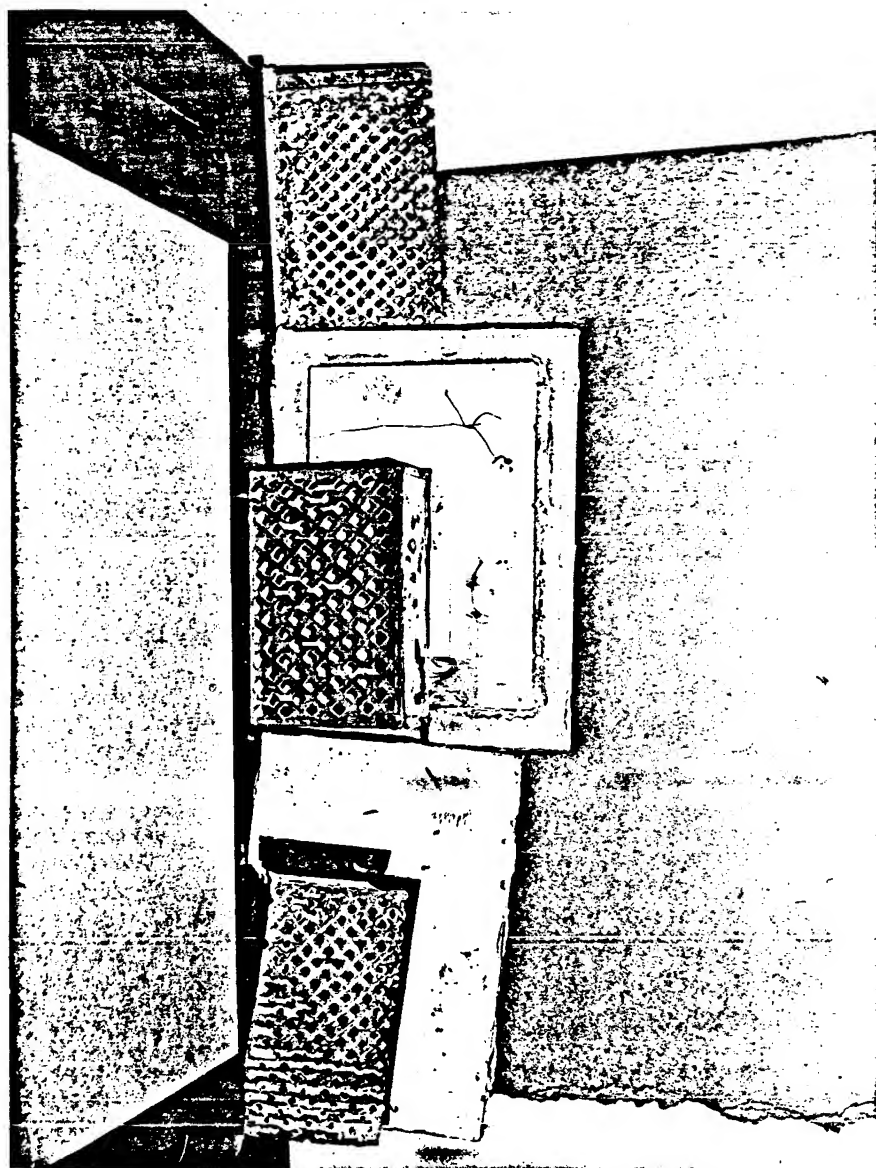
Rear view of three replicas of ventilator grills used by Subjects to replace original grills in their three cells. Note wire hooks by which grill and surrounding surface could be pulled into place after Subject's exit into the utility area.

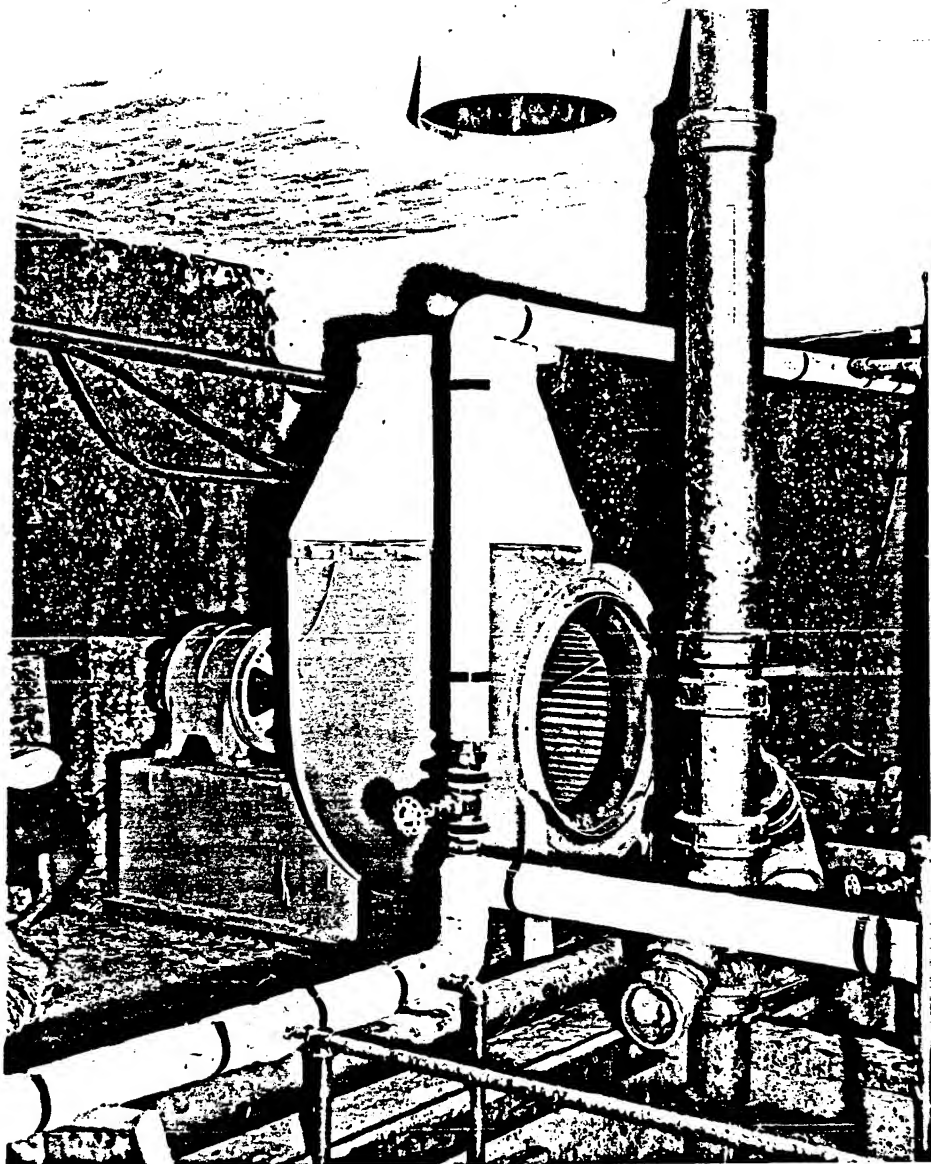
3-10 Photograph taken of the abandoned ventilating fan with opening through to the roof. Left rear and center background shows the frames in which this area was completely enclosed by drop cloths and blankets hung ostensibly to prevent splattering of paint into the cell block.

It was in this ventilator that the abandoned pantoon and two bundles of raincoats were located. Articles at the bottom of this ventilator could be reached by a long pole which had a nail protruding and could be used as a hook.

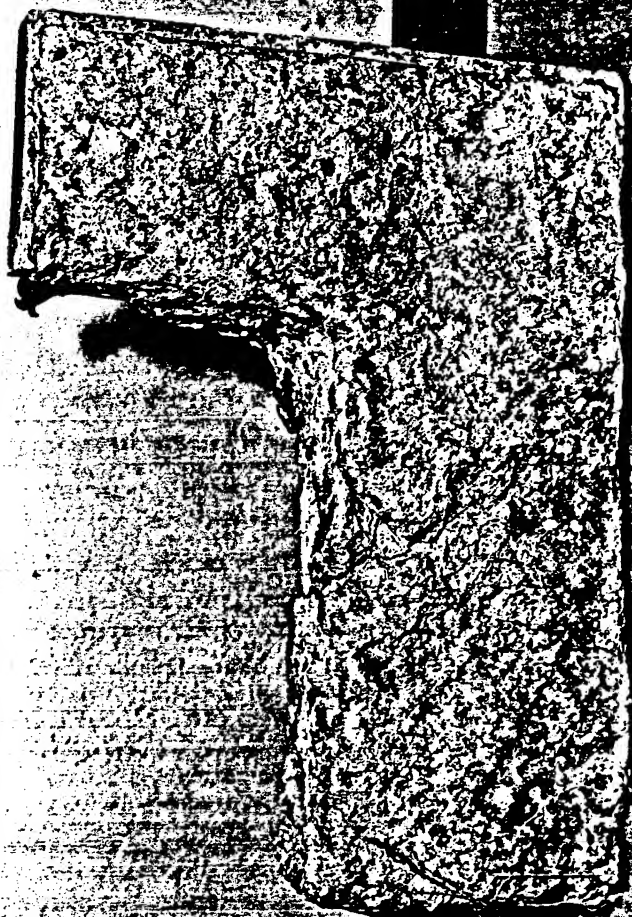
Concrete replica: this is the reproduced utility wall surface made to replace the concrete removed in order to avoid detection by a guard check along the utility corridor. This concrete was applied to hard board.

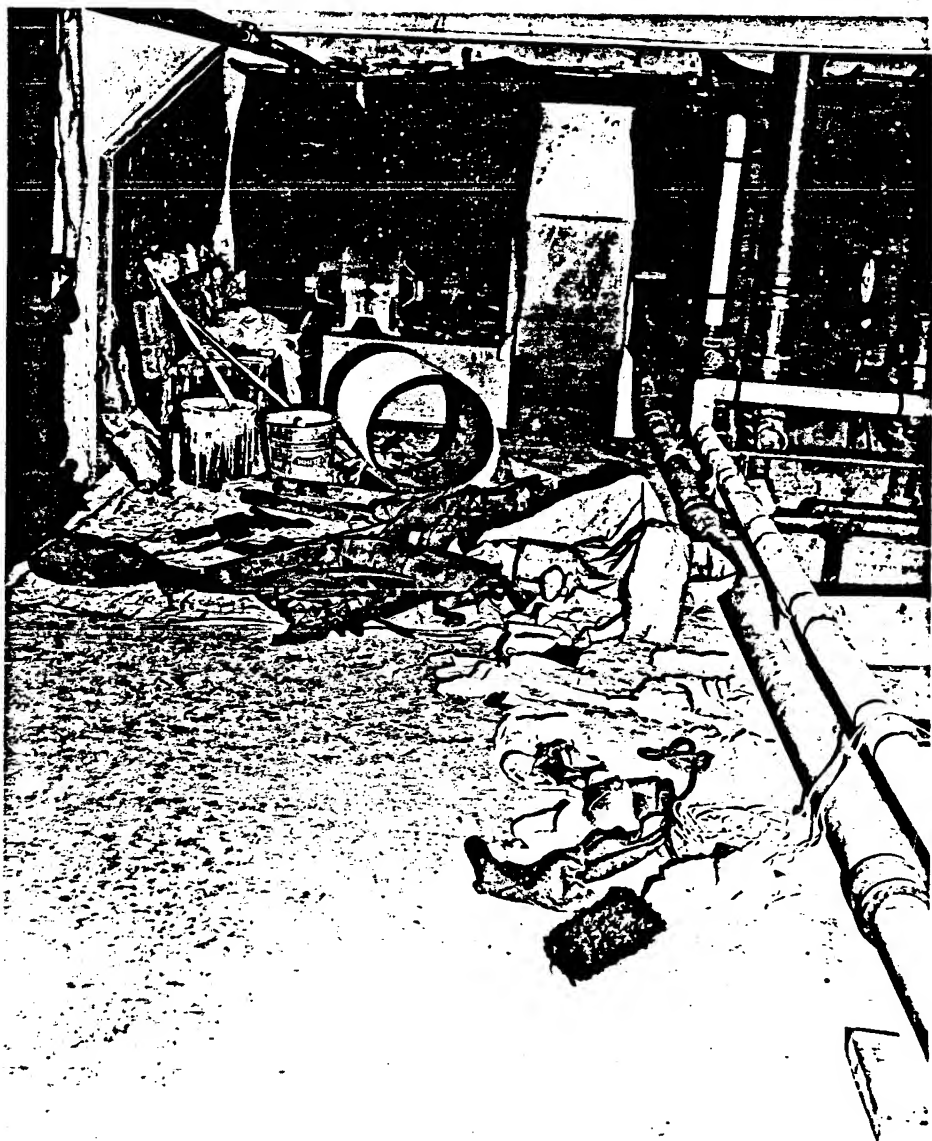
3-11 A general view looking toward the end of Cell Block B. The portion of the blanketed grill wall seen across the upper portion of the picture was across the end of the cell block. Approximately directly opposite the large black cast iron vent seen in upper right and down on the main floor was the main entrance to the entire cell area. The blanketed or screened-in area covered an area approximately thirty to thirty-five feet in length from the end of the cell block and extending on both sides, giving perfect concealment.

At lower right center may be seen a white cord which was tied to the hot water pipe crossing between Cell Block B and C and was one inch in diameter. This cord was lowered down the utility shaft and upon reaching the bottom, which was directly behind Subject's cells, it was determined to be twenty-six feet ten inches. Sections of this cord were knotted at intervals which apparently indicated the tier level reached when lowering or raising the rope. Fragments of raincoat material may be observed in general debris in center of picture. The five-gallon paint bucket from which a stick is seen protruding contained hardened cement paint and it was in this bucket a number of the Subjects' tools were subsequently located.

The heavy plank extending across the chair may have been used as the weight necessary when "vulcanizing" the seams on the raft and "Mae West" jacket.

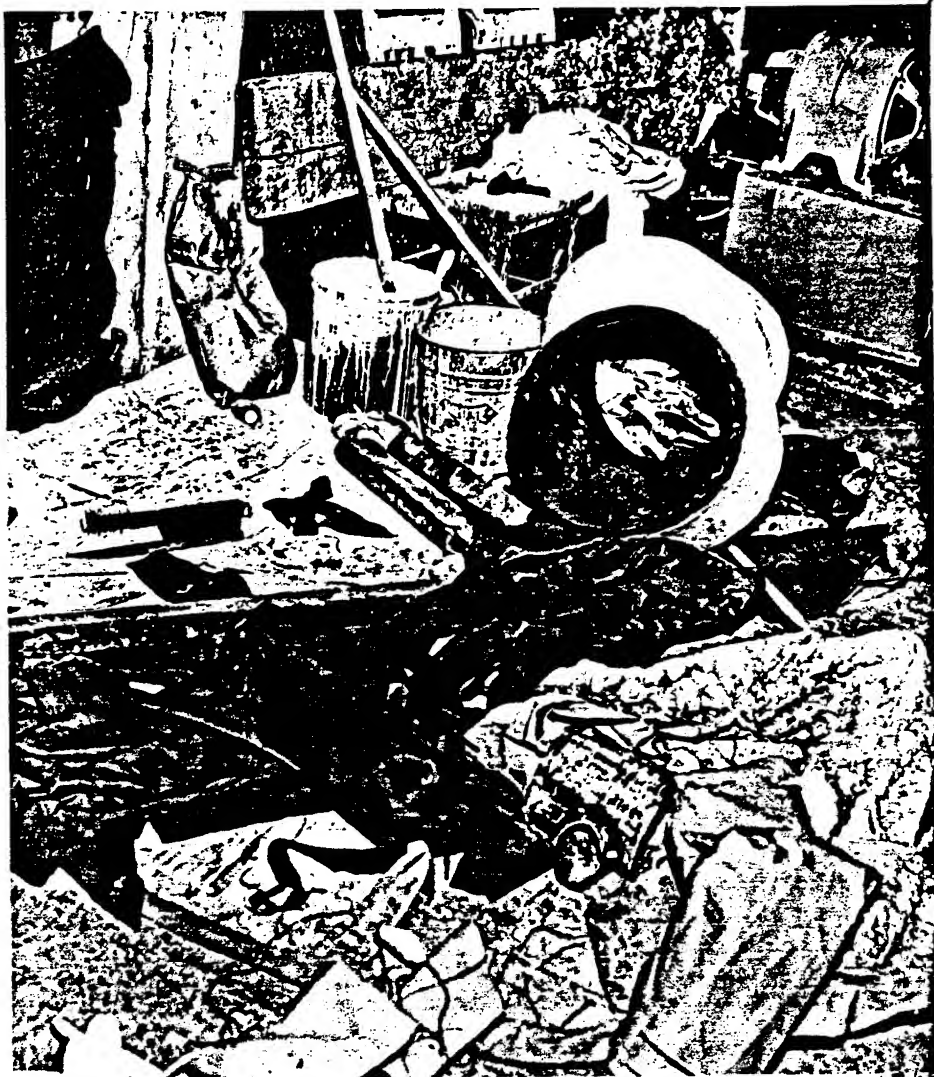
- 3-12 General view taken approximately fifteen feet from the bucket seen in center foreground. Lower left center are pieces of white Navy blanket cut in strips. The material seen at lower right is a type believed to have been used in making the raft. The goosenecked connector from the ventilating motor to the roof is seen in upper right. On the chair may be seen the remains of some brass bolts which were either machine or electrical bolts and brass washers and nuts identical to those found in the paddle.

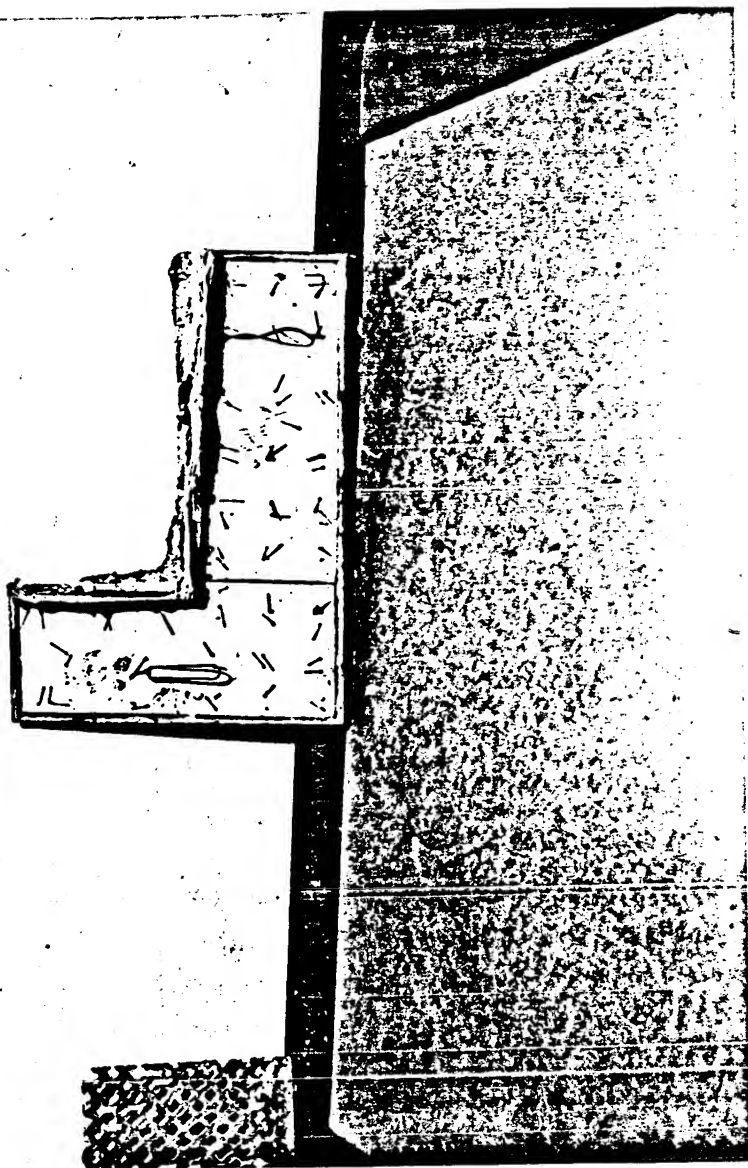
Rear view of concrete replica showing hard board. Note the wire hooks which were used to draw the replica into place from the inside of the cell.

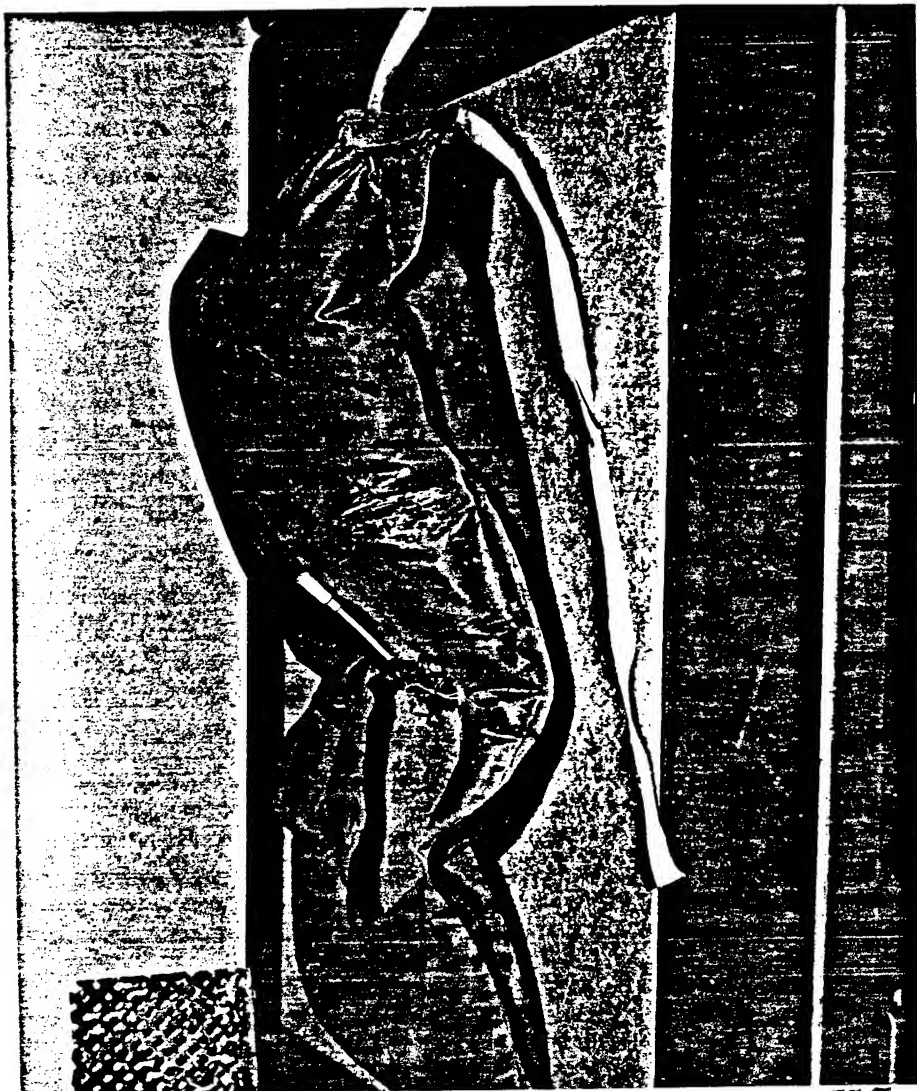
Close-up view of "yoke type" or "Mae West" life preserver showing the seam which appears to be sealed by a vulcanization type treatment, achieved by the application of heat and pressure. The heat was readily available through an exposed 1" copper hot water pipe approximately four feet long which crossed from cell block B to cell block A and was located over the top of the third tier of cells and crossed the utility well. The pressure was readily available through the use of a large heavy section of planking located in this area.
